Manhole Inspection Summary

Manhole # S39I__046MH

Insp Date: **3/27/08 3:54 PM**

Location Address: **president st**

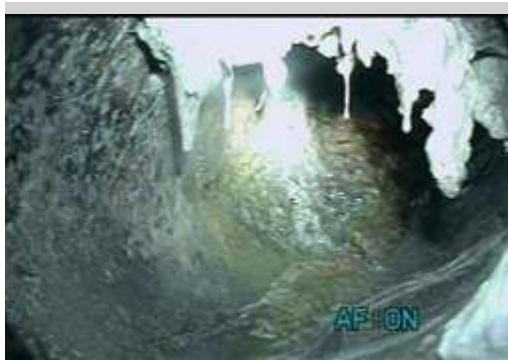
Misc.

Comments **Pipe at 9 is inside the channel couldnt get a better view.**

better view of inside of pipe in @ 9

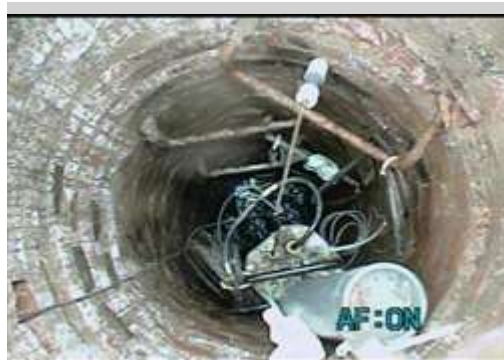
Defect 3

Condition: ☐ Sound ☐ Cracked ☐ Root Intrusion ☐ Deteriorated ☐ Leaks ☒ **Debris**

Count: **9** Missing: **0** ☒ **Corroded**

Channel debris, steps corroded

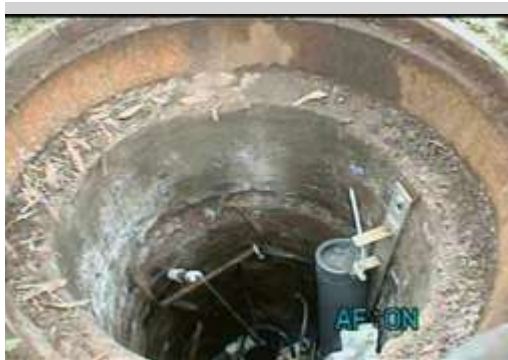
Defect 2

Condition: ☐ Sound ☒ **Cracked** ☐ Root Intrusion ☐ Loose Brick ☒ **Deteriorated**

Det. Corbel-fractures in corbel

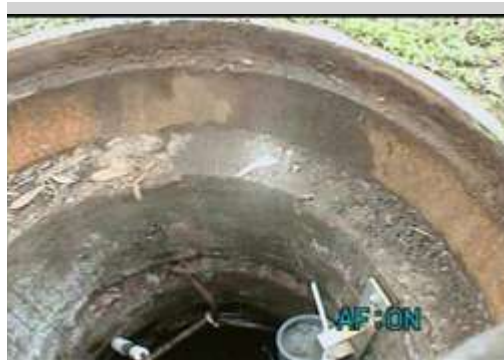
Defect 1

Offset: **4** (in.)

offset

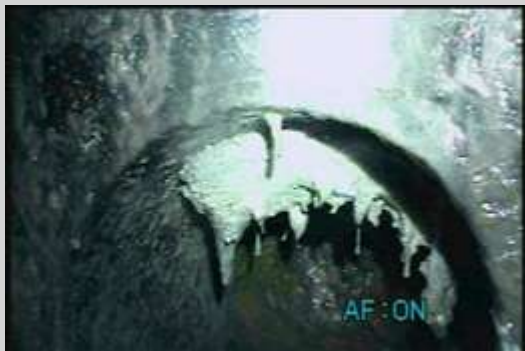
9 O'Clock Inflow

pipe is in channel

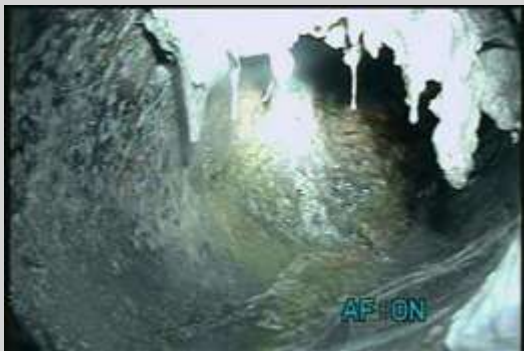
better view of inside of pipe in @ 9
